**MUNICIPAL SEPARATE STORM  
SEWER SYSTEM (MS4)  
COMPLIANCE INSPECTION**

**CITY OF HARRISBURG  
DAUPHIN COUNTY, PENNSYLVANIA**

**REPORT DATE:  
November 16, 2010**

**EVALUATION CONDUCTED:  
July 22-23, 2010**

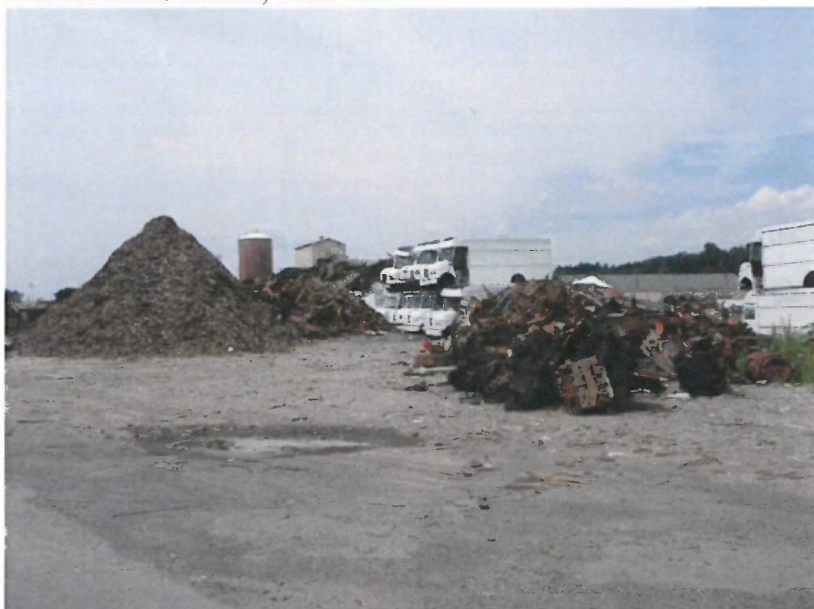
In addition, the EPA Inspection Team observed metal parts with oily residue (e.g., engine blocks) and noticed stockpiles of woody material on the ground surface without cover or containment in an upgradient area about 50–75 feet from the edge of Paxton Creek (see Appendix C, Photographs 3 and 4). The City staff members were not certain whether the Consolidated Scrap Resources facility maintained coverage for its scrap metals recycling activity under DEP's General Permit for Discharges of Stormwater Associated with Industrial Activities, PAG-03.

**Photograph 3. Outfall Observation Location #1 – Stockpiled materials stored without cover or containment in upgradient area about 50-75 feet from Paxton Creek.**

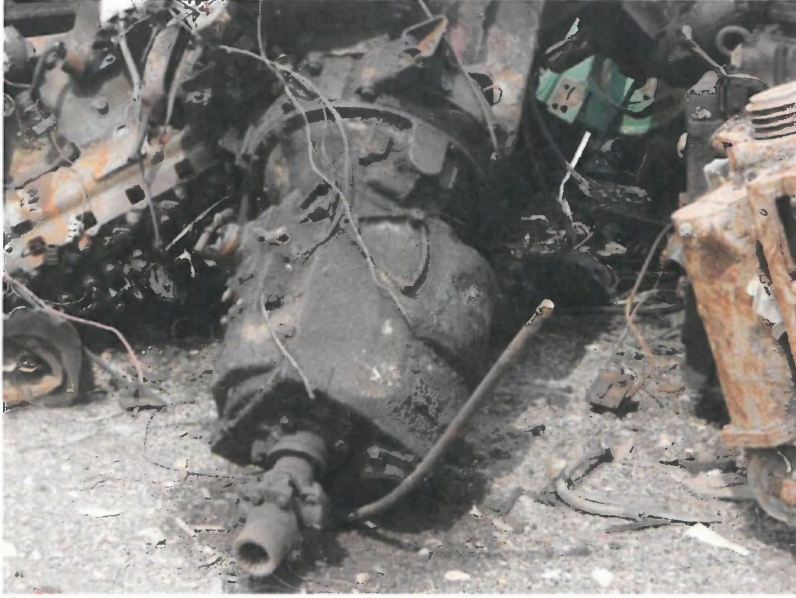
**Photograph 4. Outfall Observation Location #1 – Close-up of metal parts and engine blocks shown in Photograph 3.**
